This Errata Sheet refers to:

## ARM920T-based Microcontroller

### AT91RM9200

## Errata Sheet

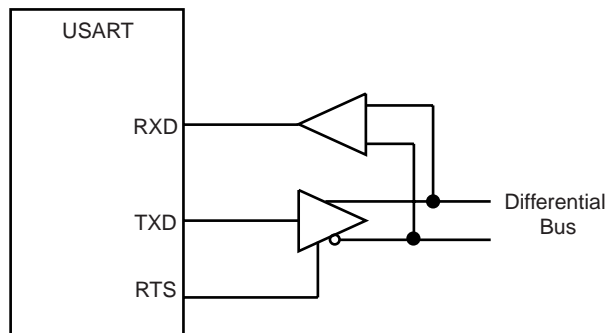
**Figure 196.** Typical Connection to a RS485 bus.

1. "The RTS pin is driven **low** when the trasnmitter is operating."  
**Should read:**  
"The RTS pin is driven **high** when the transmitter is operating."
2. "Significantly, the RTS pin remains **low** when timeguard is programmed..."  
**Should read:**  
"Significantly, the RTS pin remains **high** when timeguard is programmed..."
3. Figure 196 and Figure 197 give incorrect descriptions of RTS behavior. The correct descriptions of RTS behavior are as follows:

The correct sentences and correct figures are to be implemented in the next update of the datasheet, Lit° Number 1768C.
