<b>PCN Number:</b>	20161114000	<b>PCN Date:</b>	Nov 15, 2016
<b>Title:</b>	ADC32xx/34xx Product Family Design Change		
<b>Customer Contact:</b>	<a href="#">PCN Manager</a>	<b>Dept:</b>	Quality Services
<b>Proposed 1<sup>st</sup> Ship Date:</b>	Nov 15, 2016	<b>Estimated Sample Availability:</b>	Date provided at sample request
<b>Change Type:</b>			
<input type="checkbox"/>	Assembly Site	<input type="checkbox"/>	Assembly Process
<input checked="" type="checkbox"/>	Design	<input type="checkbox"/>	Electrical Specification
<input type="checkbox"/>	Test Site	<input type="checkbox"/>	Packing/Shipping/Labeling
<input type="checkbox"/>	Wafer Bump Site	<input type="checkbox"/>	Wafer Bump Material
<input type="checkbox"/>	Wafer Fab Site	<input type="checkbox"/>	Wafer Fab Materials
<input type="checkbox"/>	Software	<input type="checkbox"/>	Part number change
<input type="checkbox"/>		<input type="checkbox"/>	Assembly Materials

Texas Instruments Incorporated is announcing an information only notification for a design change on the ADC32xx/34xx product family of devices.

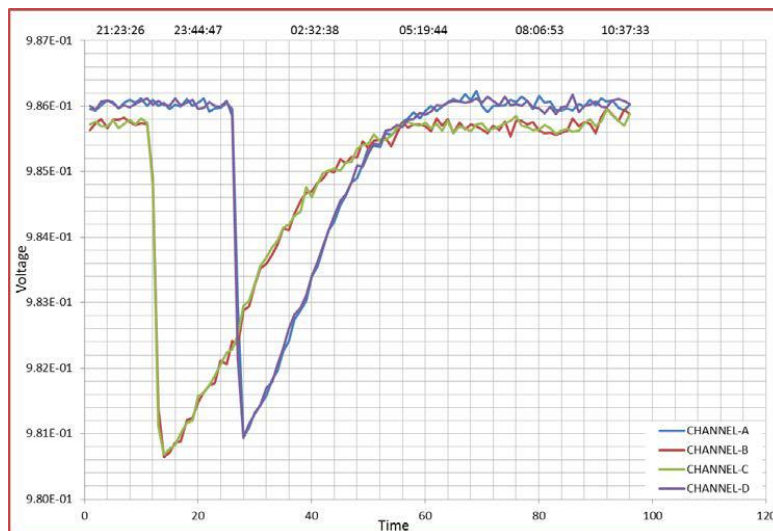
1. ADC's gain error (1) shows a 'glitch' when a fresh device is tested.
  - a. For quad channel part (ADC34xx/34Jxx), channel A and D show the glitch together, while channel B and C show it together. For dual channel part (ADC32xx/32Jxx), glitch occurs at the same time for channel A and B.
  - b. When glitch occurs, the gain error increases by ~0.5%.
  - c. The glitch shows a very slow settling profile with a time constant of 'hours'.
  - d. Once settled, the glitch doesn't occur again, i.e. the glitch occur only once for a given device.
  - e. This issue doesn't cause any impact on AC performance.
  - f. The issue affects only time-domain applications.
2. Lab test show that glitch in gain error is a result of glitch in ADC's reference voltage as shown in figure 1

Figure 1 Glitch on ADC reference voltage

The floating gate of inverter in unused cell is connected to deterministic state (AVDD supply) in new Silicon. While it solves the problem, it doesn't impact any parameter (performance, power or timing) of device in any possible way since the unused cell is not used anywhere in design for any purpose.

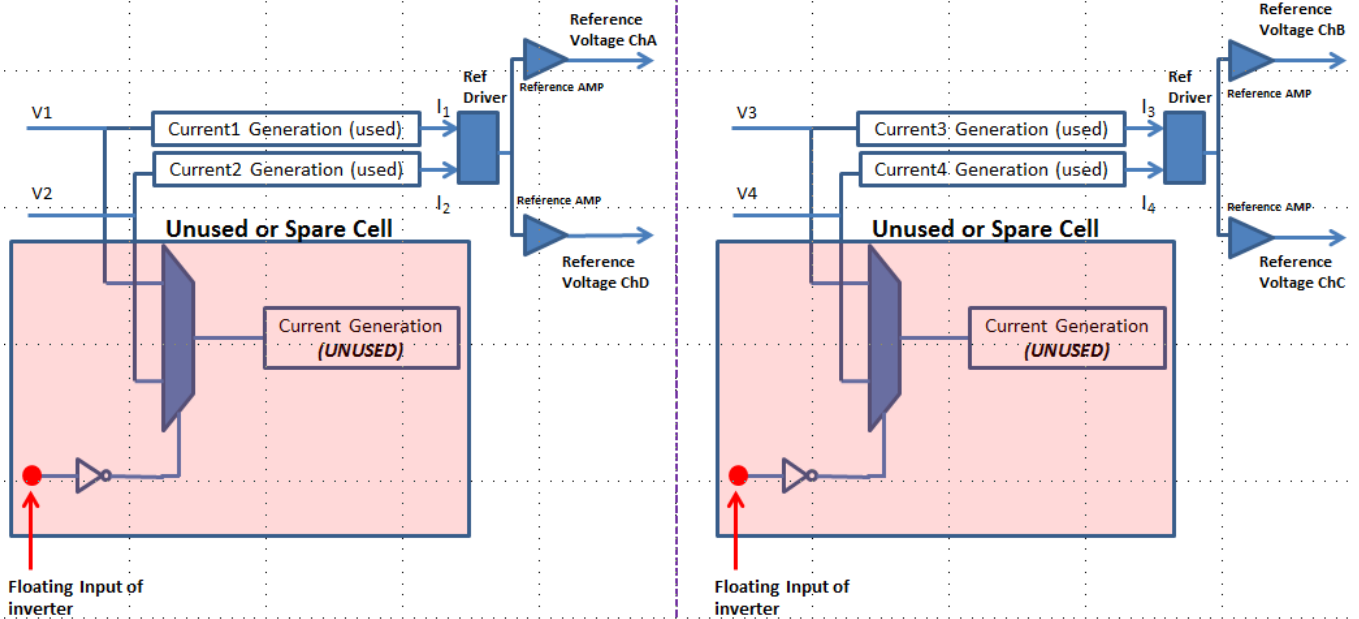
Figure 2 explains the circuitry inside a quad channel device (ADC34xx/34Jxx) which causes the problem. For the dual channel device (ADC32xx/32Jxx), channel A&D represent the two channels. Channel **A and D** for quad channel device  
 Channel **B and C** for quad channel device  
 (Channel **A and B** for dual channel device)

**Figure 2 Reference Voltage generation inside ADC3xxx/3xJxx devices**

- Bias Voltages (V1,V2) and (V3,V4) are used to generate currents for reference driver for channel A&D, and channel B&C respectively.
- Inside device, there are two unused cells to generate current (one for channel A&D, other for channel B&C). The bias voltage of these unused cells is chosen by multiplexer. The selection line of multiplexer is driven by a floating input inverter.
- This floating gate of inverter in unused cell causes V1 and V2 to short temporarily, resulting in glitch in reference output of CHA and CHD. Same phenomenon is seen by CHB and CHC.
